Technical Report HL-93-3  
June 1993

## Demonstration Erosion Control Project Monitoring Program

### Fiscal Year 1992 Report

#### Volume VII: Appendix F Model Study of Bendway Weirs as Bank Protection

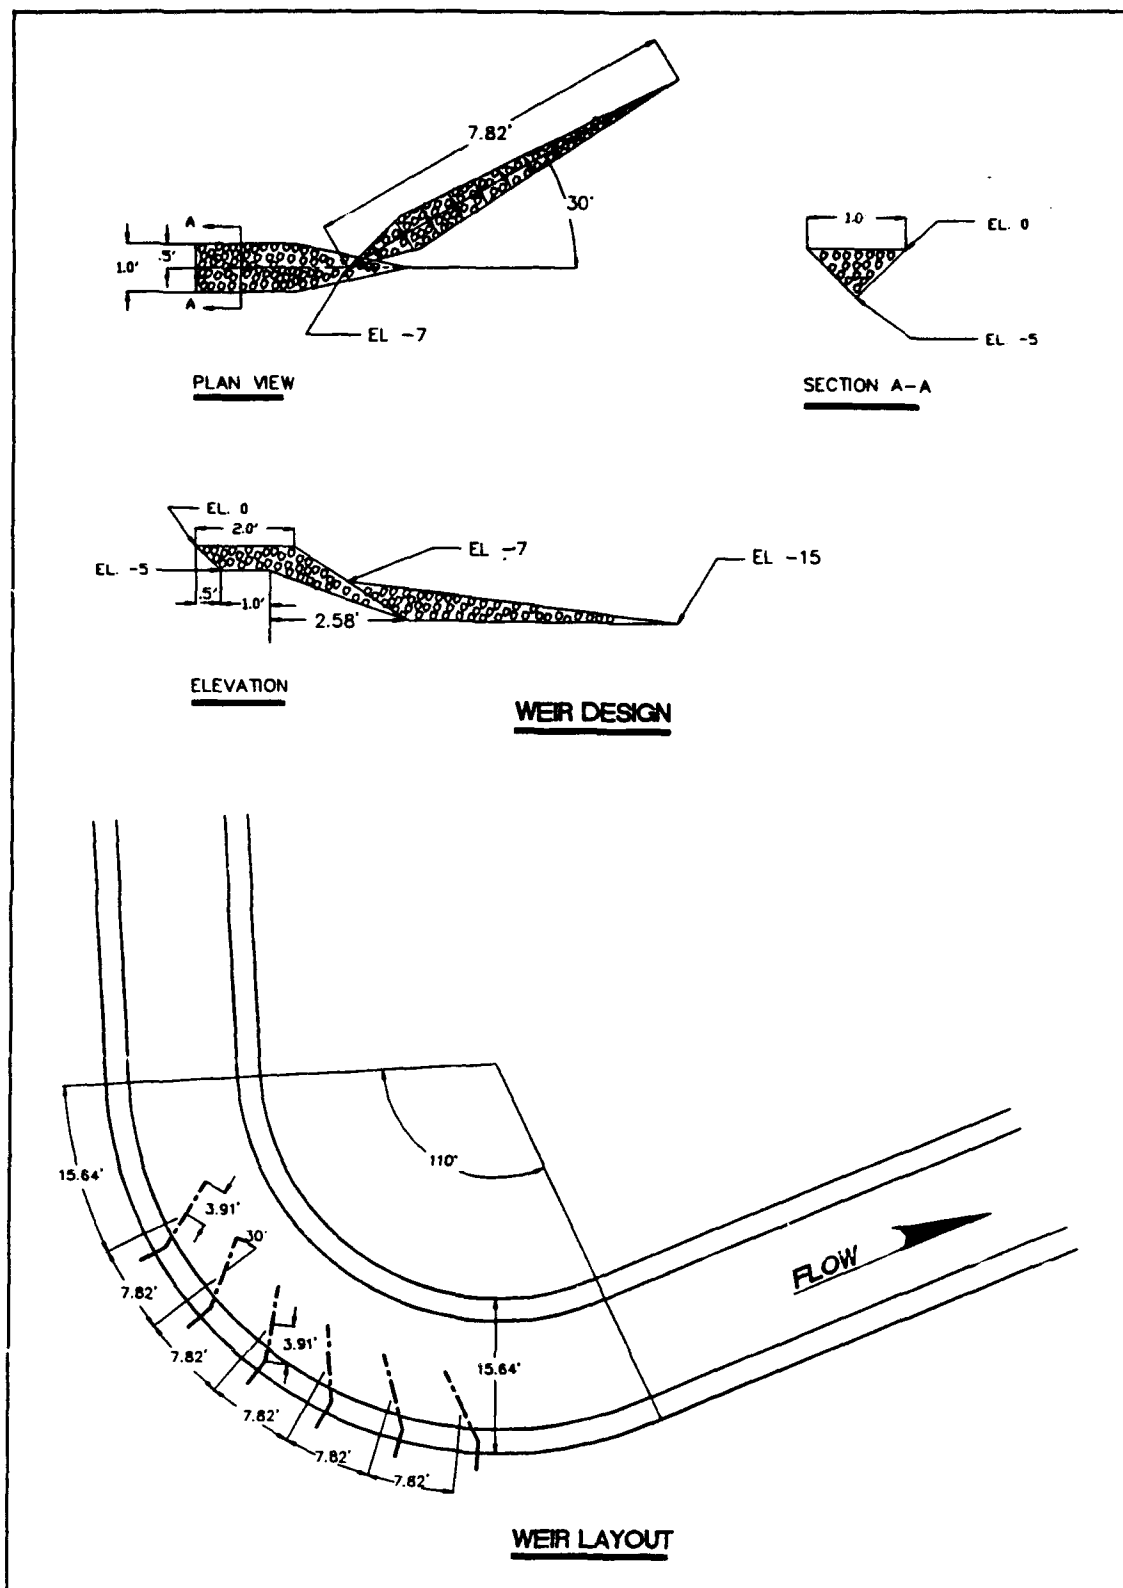
Figure 1. Test 1 weir layout and design

was comprised of six weirs spaced 7.82 ft apart (spacing equal to one-half top bank width) with the most upstream weir located 15.64 ft downstream of the point of curvature of the bend (equal to the top bank width). The weirs were angled upstream 30 degrees to a line perpendicular to the bankline at the weir root. The weir root or key into the bank was similar to the method that LMK presently uses on hard points. The elevation of the weir where it intersected the bank was -7 ft (approximately mid-bank elevation) with the stream end of the weir at the channel invert of el. -15 ft. This produced a weir section which was particularly thin on the stream end; however, it was felt that such a design may provide a degree of armoring as scour occurred and reduced the attack on the stream end of the weir. The stone used to construct the weirs had a  $D_{50}$  of about three-eighths inch. Prior to installation of the weirs and initiation of testing, the channel bed was remolded to the initial bed configuration (Plate 1).

**Description.** For Plan 1 the bendway weir configuration shown in Figure 1 was installed into the study reach. Several of the parameters for the plan were based on the top bank width of the study channel. This was done to make the study results applicable to the DEC Project. The plan

As a first test on the use of bendway weirs to reduce bankline recession, it was felt that this test was very successful. It was obvious that some additional design and enhancement was necessary and possible, but the amount of testing time available was limited. From Test 1 it was apparent that the length of weirs could be reduced, a greater stone section was required on the stream end of the weir since a small amount of end scour significantly reduced the length of the weir as the stone was launched, and additional weirs would help the bank recession in the straight reach downstream of the bend. Although not as apparent as some of the above observations, it seemed that the spacing could be increased without an adverse effect on the weir field performance. However, it was decided that the spacing used would be maintained and no additional weirs would be added to the field. This was based on conducting as many tests as possible changing only weir length and height. It was hoped that additional tests could be conducted at a later date to investigate some of the other variables.

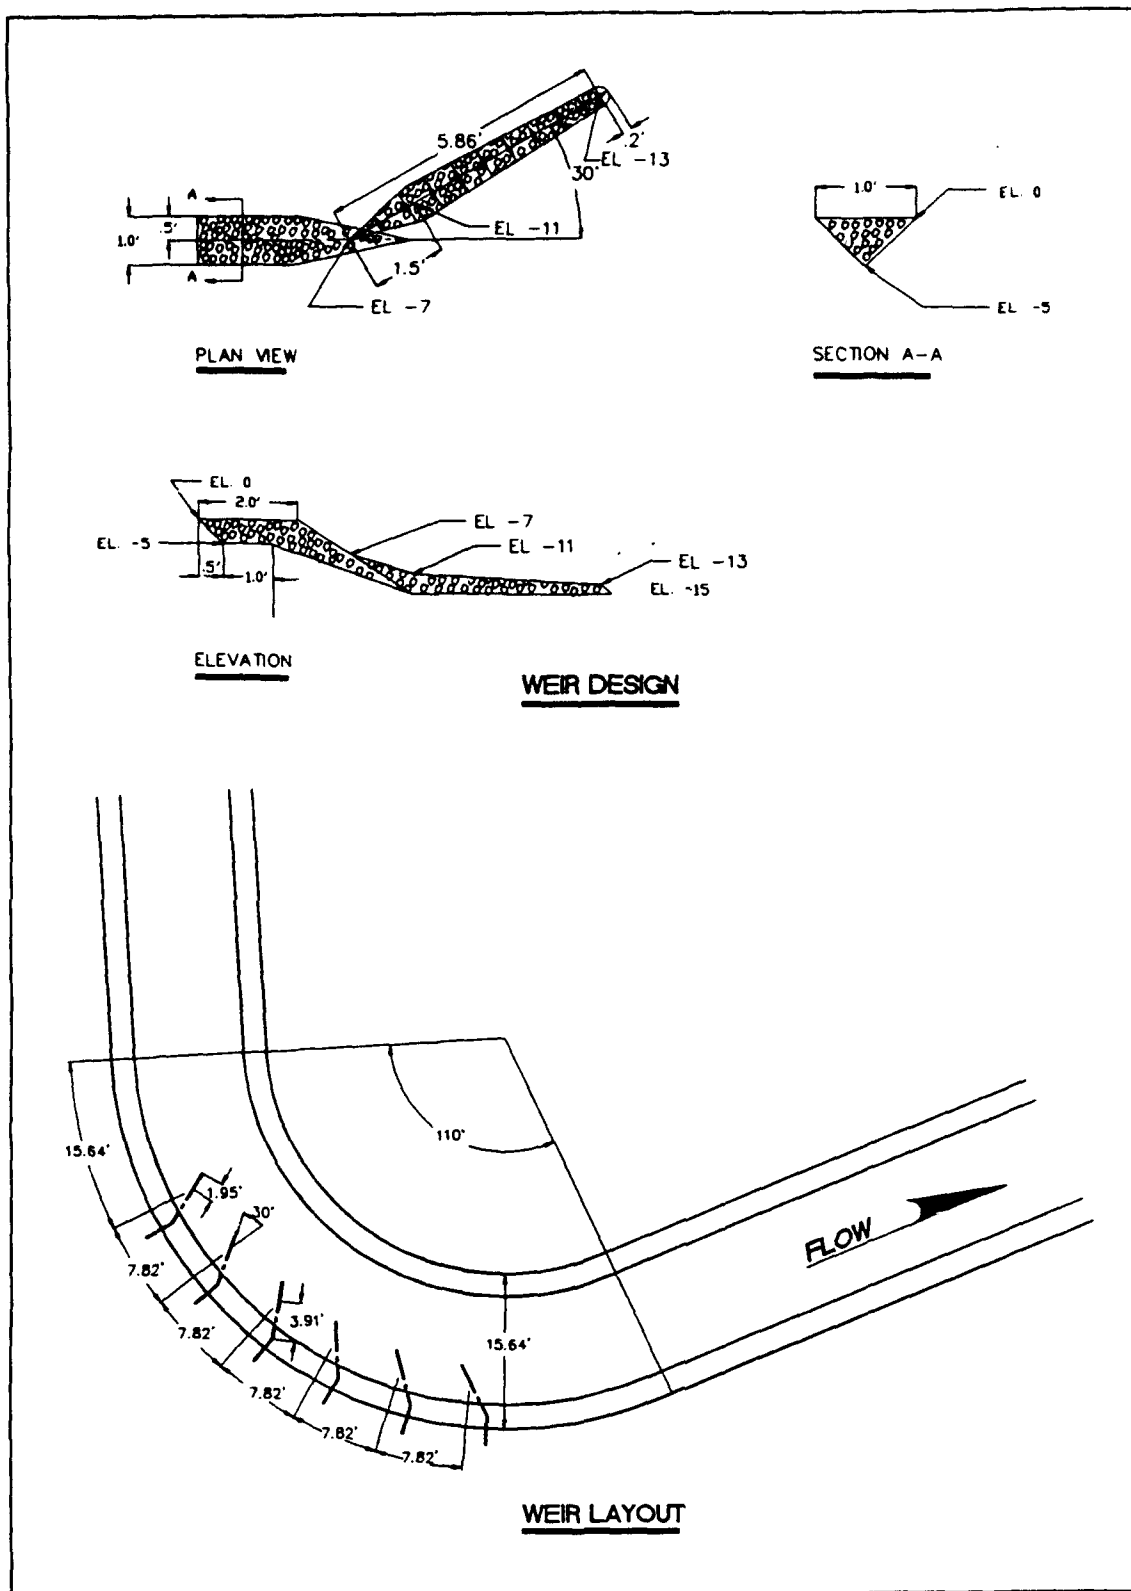
Figure 2. Test 2 weir layout and design

**Description.** Plan 2 was the same as Plan 1 except the weir length was reduced to 5.86 ft (three-eighths of top bank width) and the weir height

was modified (Figure 2). The intersection of the weir with the bankline remained at el -7 ft with a 1.5 ft transition to el -11 ft. From that point the weir sloped to a stream end elevation of -13 ft with the stone on its natural angle of repose to the channel invert of el -15 ft. Prior to installation of the weirs and initiation of testing, the channel bed was remolded to the initial bed configuration (Plate 1).

**Results.** Results of Plan 2 tests are presented on Plates 7 and 8. Test results indicated that essentially no bankline recession occurred upstream of Range 25. The maximum bank recession of about 1.5 ft occurred around Range 33 with about 1.0 ft of recession at Range 31. The maximum scour at the stream end of the weirs was to el -18 ft, and the recession of the inside of the bend was significantly reduced when compared to Plan 1 test results. Due to the increase in the weir section at the bankline there was a tendency to increase the deposition of material at the toe of the bank slope within the weir field. Point velocities (Plate 8) indicated that the weirs continued to have a significant effect on the currents by redirecting the higher velocities from the outside of the bend and toward the inside of the bend. However this tendency was somewhat reduced with a decrease in the maximum velocity due to the decrease in weir length when compared to Plan 1 (compare Plates 6 and 8).

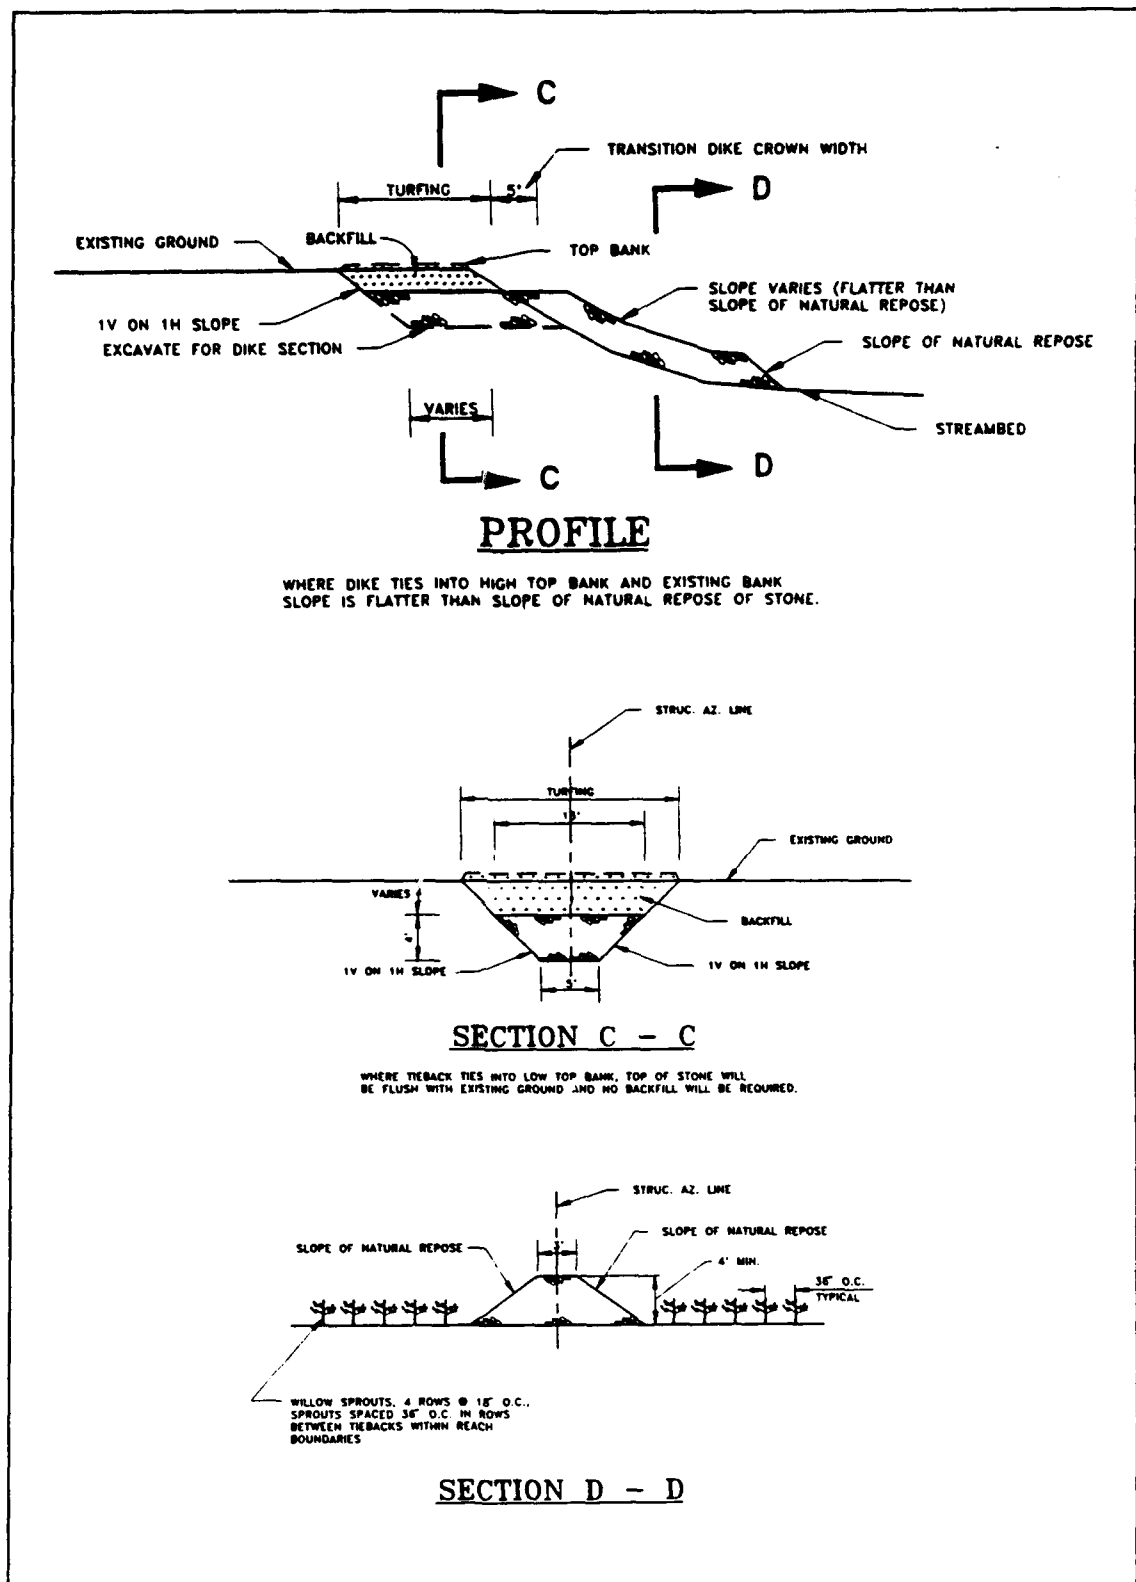
Figure 3. Plan 3, hard point design

**Description.** A portion of the plans and specification drawings used by LMK for hard points is presented in Figure 3. This was the particular design used in the study to compare the effectiveness of bendway weirs verses a typical hard point design. The hard point field consisted of six structures in the same locations in the bendway where the weirs had been tested. Prior to construction and testing of the hard points, the channel was remolded to the initial configuration (Plate 1).

**Results.** Results of the test of hard points (Test 3) are presented on Plates 9 and 10. Results based on the channel configuration (Plate 9) indicated that the hard points were effective in virtually eliminating bank recession in the bendway within the hard point field. Through the bendway there was slight scour near the stream end of each hard point, but that scour did not appear to cause any bankline instability. Once the flow exited the bendway however, the effects of the hard points did not extend

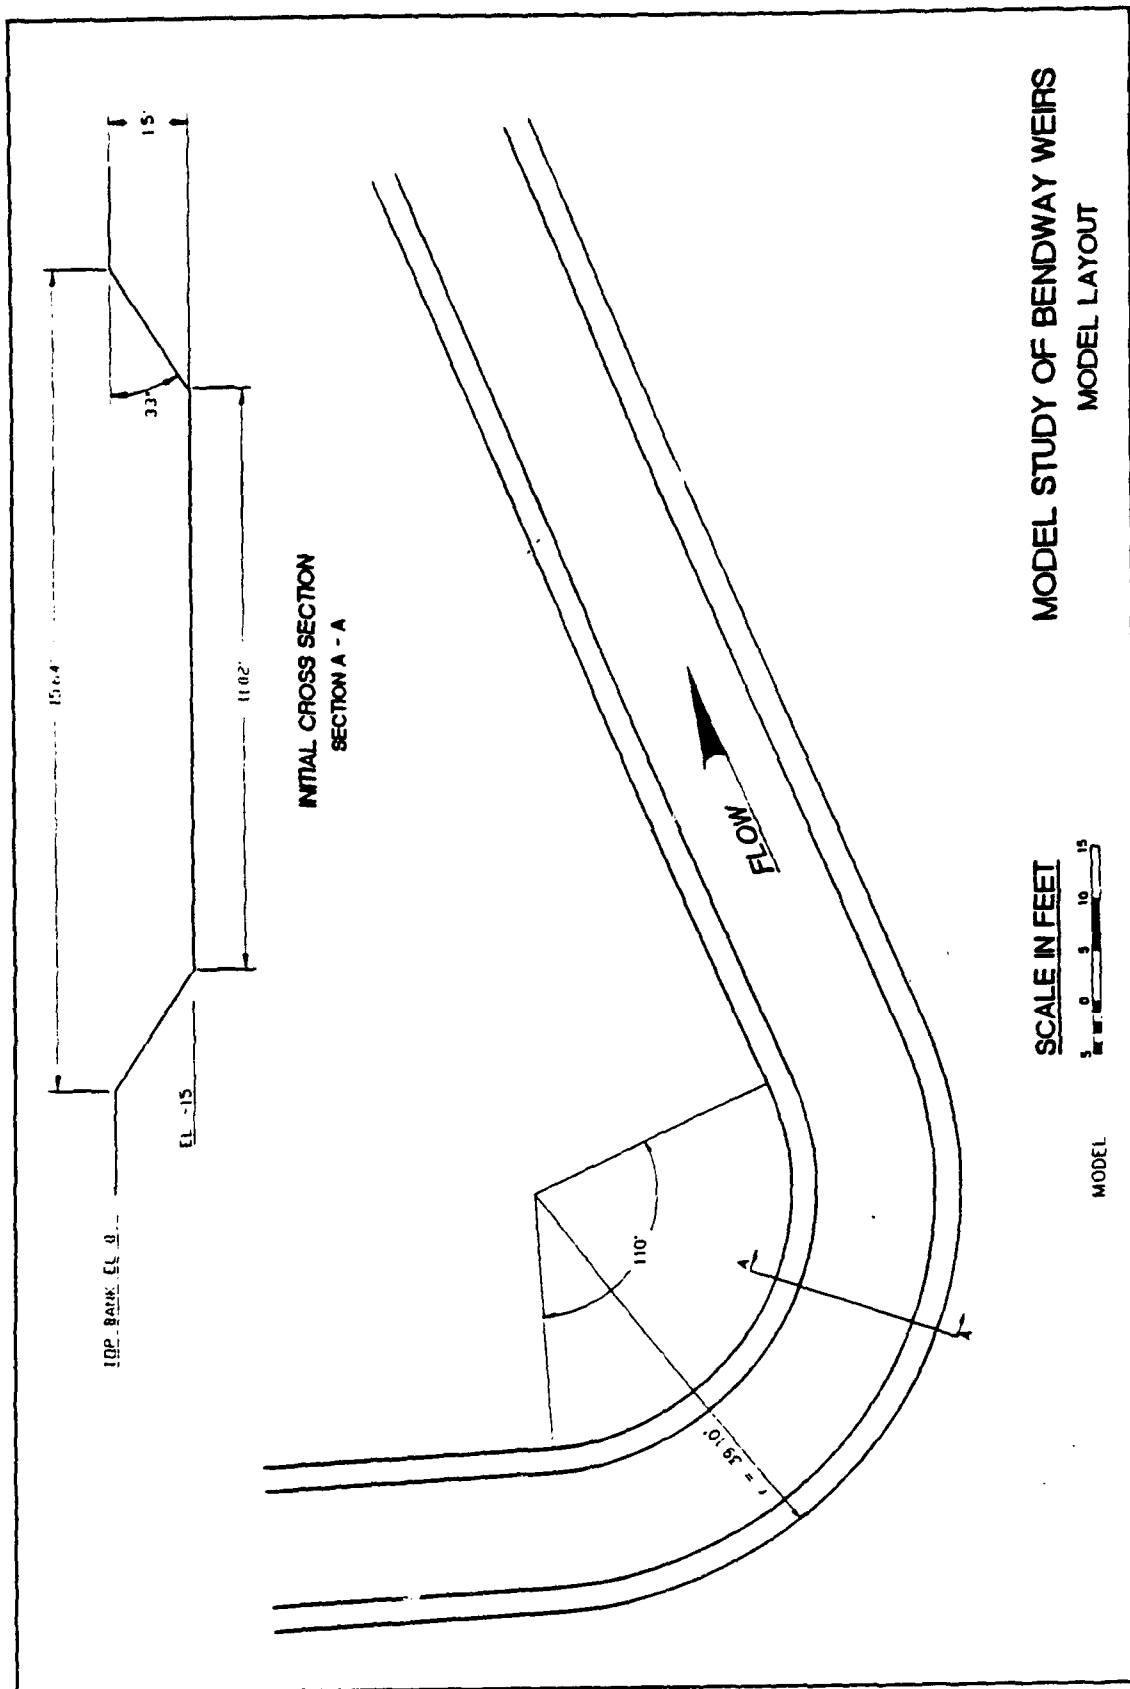
The initial channel planform and uniform channel cross-section installed in the model is shown on Plate 1. The elevations shown on the cross-section are relative to the study only and were established for ease of measurement during testing. The top bank was assumed to be at elevation 0 ft, and since the constructed channel depth was 1.5 ft, the channel invert was set at el -15 ft. This was a factor of 10 and eliminated the need to present all of the study data with decimal points. All horizontal measurements presented in this report are actual measurements without a factor of 10 adjustment. The bed and bank material used in the study was a fine grained sand with an almost uniform size distribution. The sand has a specific gravity of 2.65 and a size distribution with a  $D_{15}$  of 0.17 mm, a  $D_{50}$  of 0.23 mm, and a  $D_{85}$  of 0.30 mm. This particular facility has been used for movable-bed modeling of specific river reaches and was useful for this study since it has sufficient pump capacity and the study material (sand) is similar to what may be present in parts of the DEC Project.

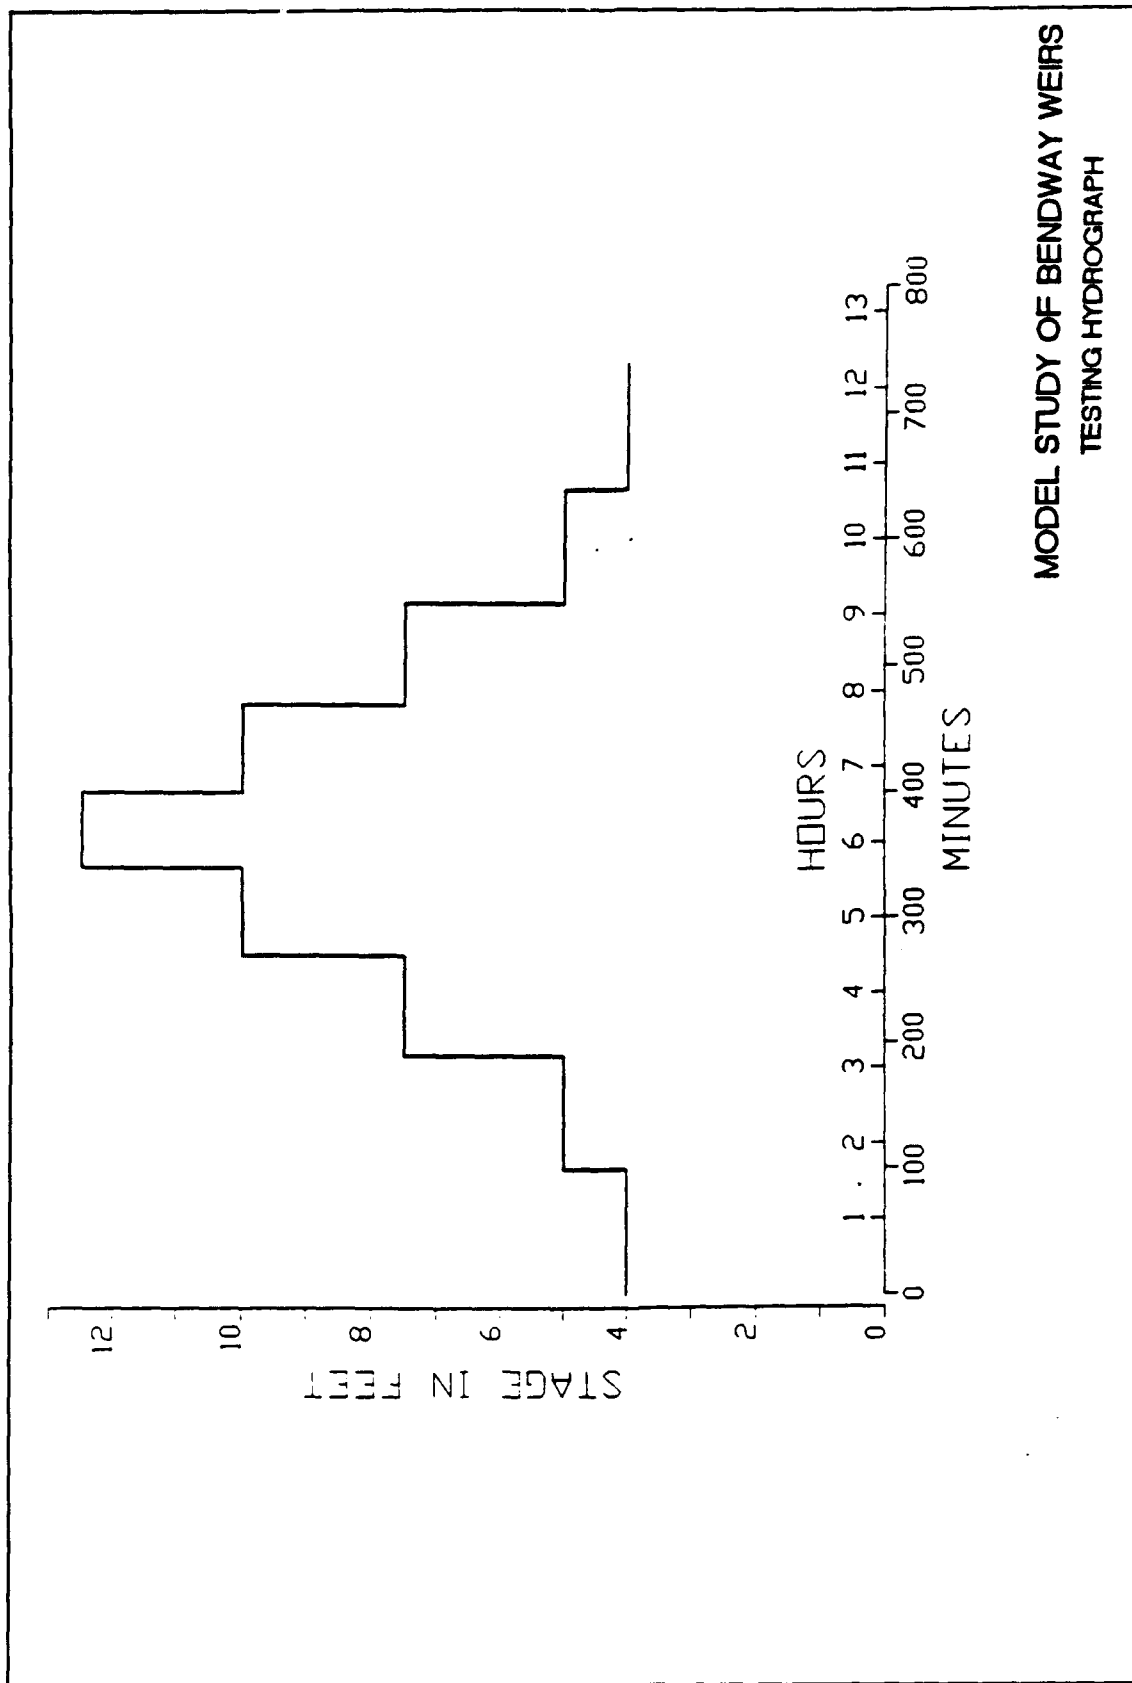
Plate 2

Prior to testing, a stage hydrograph was developed to use on the study. Since this was not a study of a particular reach, no prototype data were available; therefore, a symmetrical stage hydrograph was developed (Plate 2), and the discharge was adjusted in the study reach until reasonable sand movement was obtained for all stages tested. The criteria used for evaluation of the sand movement was as the stage increased the movement of bed and bank material also increased. The amount of time each flow lasted was dependent on obtaining a reasonable amount of bank recession in a reasonable amount of time. The specific hydrographic information relative to the stages maintained is presented in Table 1.

<b>Table 1 Hydrographic Information Used</b>			
<b>Stage Elevation, ft</b>	<b>Percent of Bankfull Stage</b>	<b>Time, min</b>	<b>Percent of Time Equal to or Less than Stage</b>
4.0	26.7	200	27.0
5.0	33.3	180	51.4
7.5	50.0	160	73.0
10.0	66.7	140	91.9
12.5	83.3	60	100.0
Note: Total running time of hydrograph 740 minutes or 12 hours and 20 minutes.

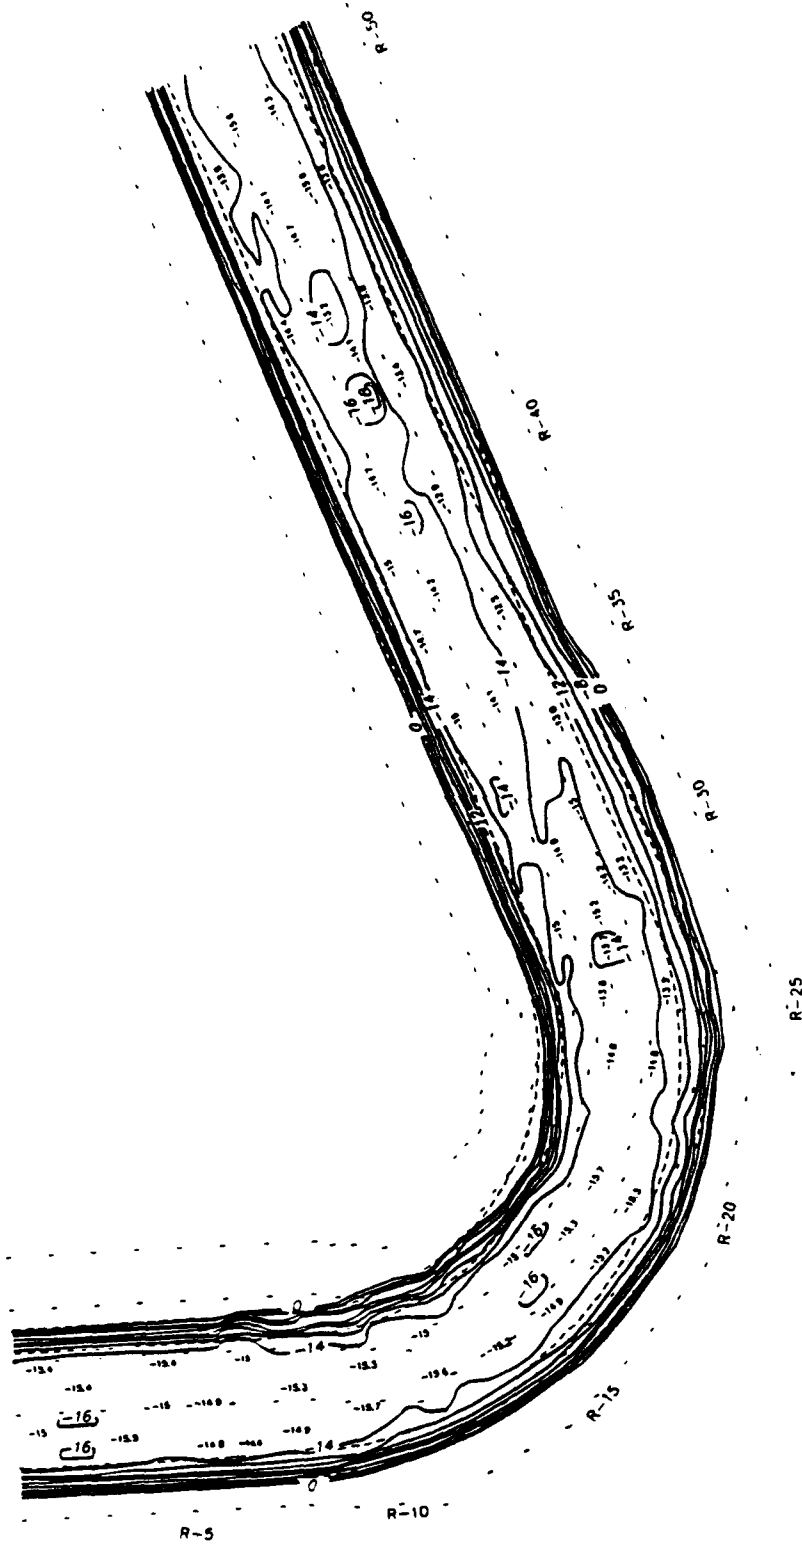
# MODEL STUDY OF BENDWAY WEIRS CHANNEL CONFIGURATION BASE TEST

**Results.** The results of the base test are presented on Plates 3 and 4. The ending channel configuration (Plate 3) indicated that very little right bank recession took place in the upstream portion of the study, but about Range 17 some recession was initiated until its maximum recession of about 2 ft occurred along the right bank around Range 31. There was essentially no change in the channel invert elevation with the ending survey indicating elevations of -14 and -16-ft. The only exception was where the material scoured from the right bank upstream of Range 31 and tended to deposit along the slope toe downstream of Range 31. In this area there was a slight tendency to develop a crossing and have the thalweg of the channel move from the right to the left. The point velocities (Plate 4) indicated that the velocities were initially fairly uniform and that they remained that way through the crest of the hydrograph to the ending 5-ft stage. Although there were some variations in individual quantities during the test, no significant velocity changes were observed.

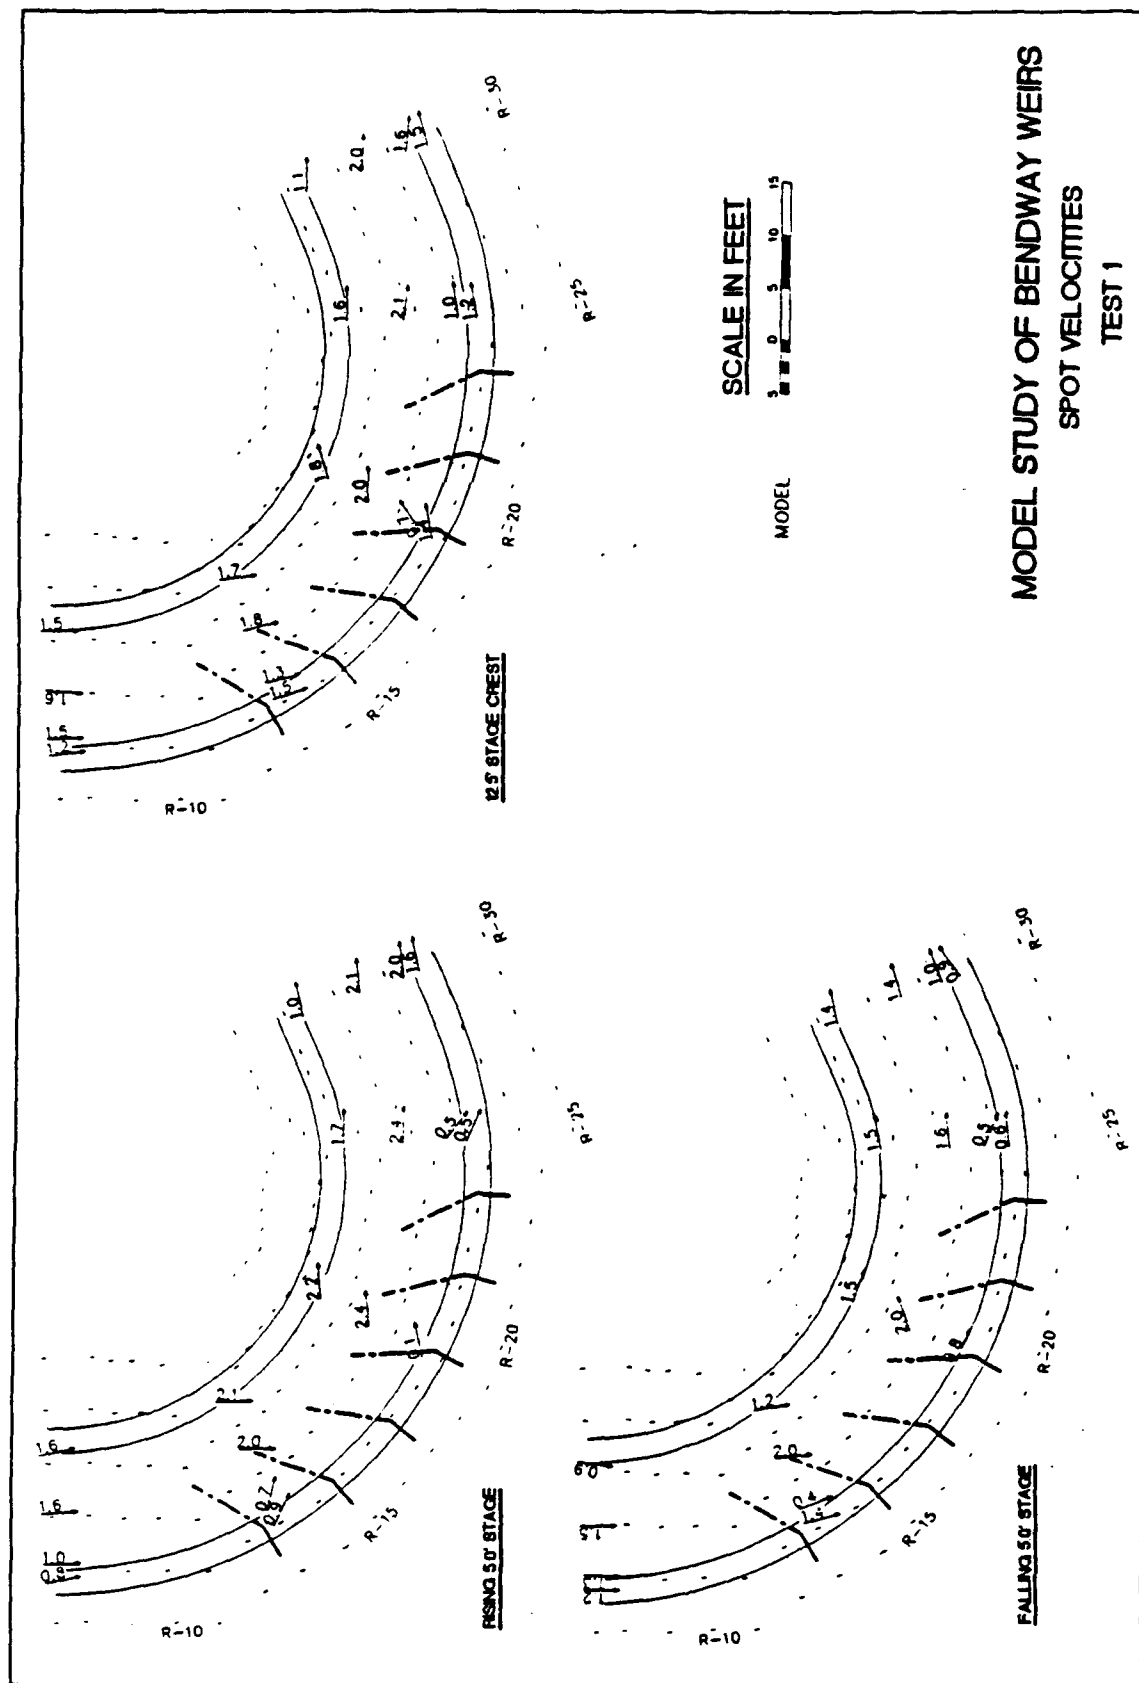
Plate 6

**Results.** The bed configuration at the end of the hydrograph (Plate 2) is presented on Plate 5. The results indicated that there was essentially no bank recession to Range 25. Downstream of that point the bank recession was reduced, with the maximum of 1.5 ft occurring at Range 33. Compared to the base test the bank recession at Range 31 was reduced from 2 ft to about 6 inches. Scour as great as 5 ft occurred at the stream end of the weirs; however, the left bank of the bendway also scoured somewhat indicating that the weir length was probably too great. This conclusion was supported by the point velocities taken during the test (Plate 6). The weirs were effective in redirecting the currents from the outside toward the inside of the bend; however, the magnitude of those velocities was increased to over 2 fps in some instances and toward the inside bank.

downstream, which had been the case with the bendway weirs. To Range 27 there was no bank recession, but from that point downstream the bank recession rate increased. The maximum recession of about 2.2 ft occurred near Range 32 and the recession at Range 31 was about 1.5 ft. Point velocities taken during the test (Plate 10) indicated that the hard points had a greater effect on the low flows (5 ft stages) than on the high flow (12.5 ft stage) when compared to the base test. The effect of the hard points on the currents was not as dramatic as what had occurred with the bendway weirs. In the case of the hard points, the maximum velocities as the bend was exited tended to be on the right descending bank, while with the bendway weirs the maximum velocities were near the center of the channel (compare Plate 10 with Plates 6 and 8).

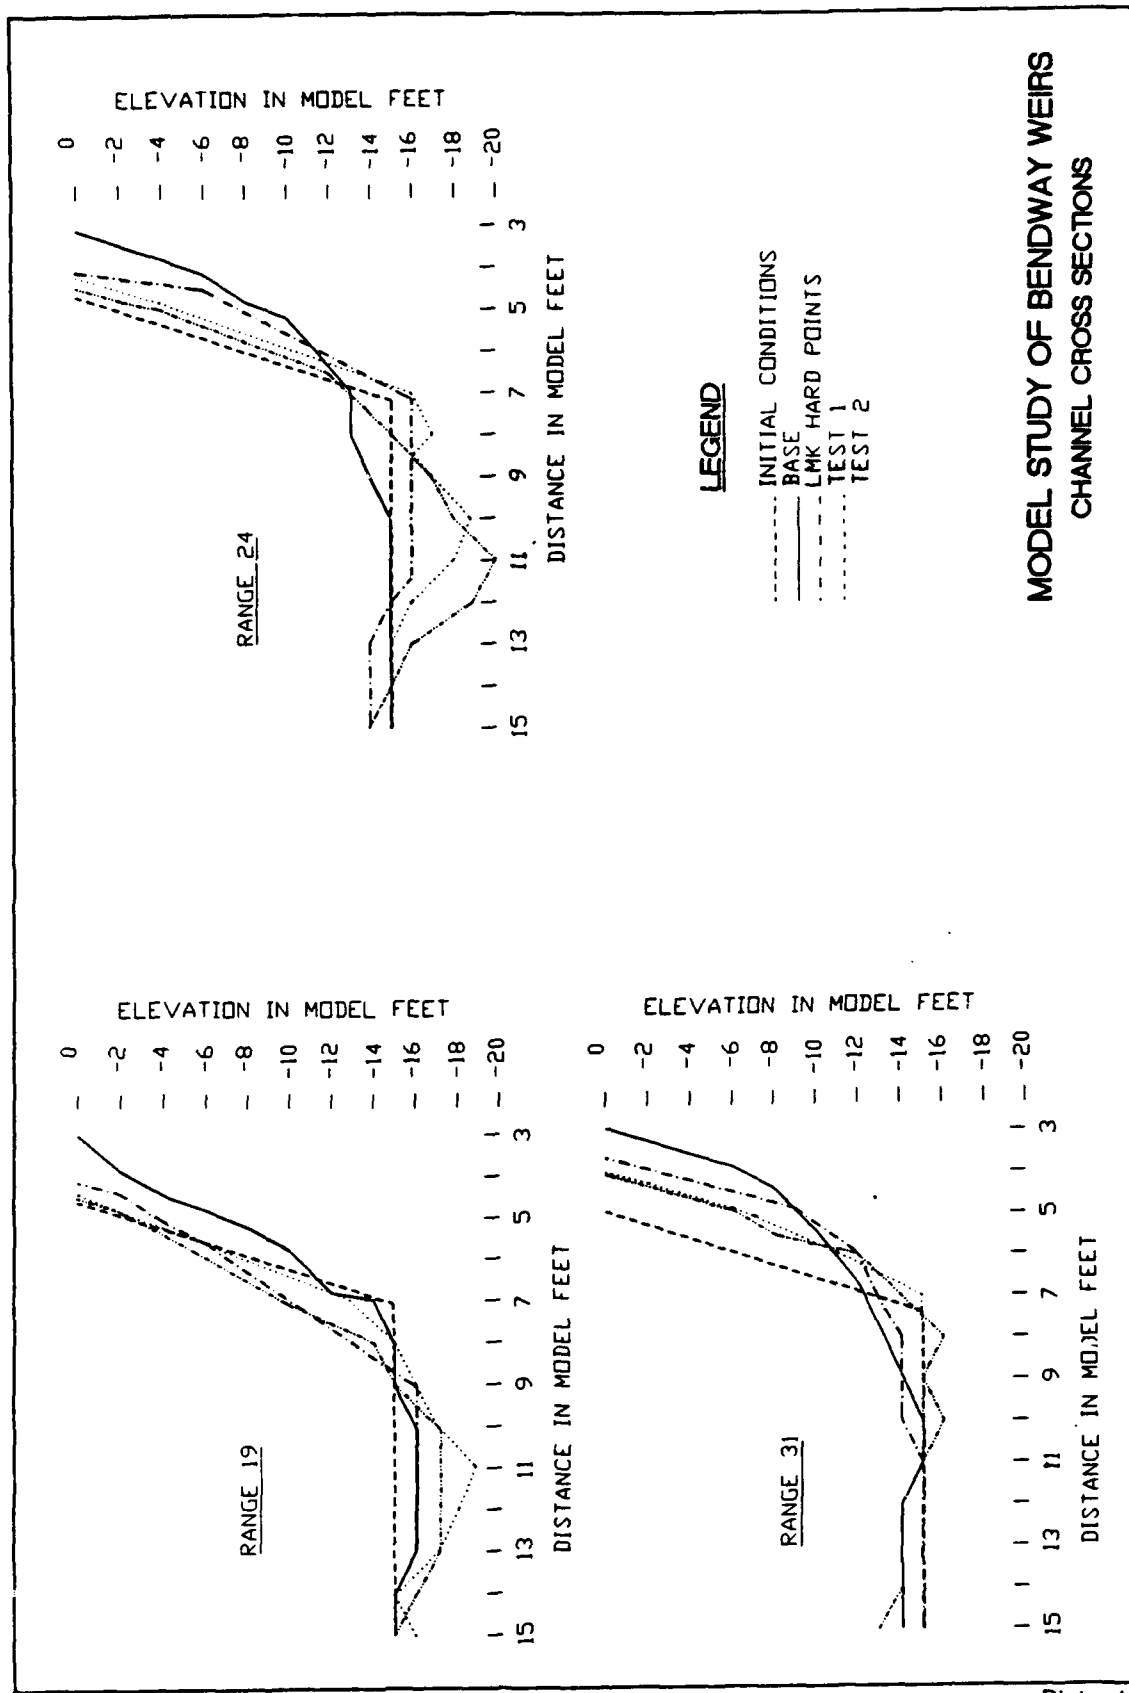
MODEL STUDY OF BENDWAY WEIRS  
CHANNEL CROSS SECTIONS

Since this was not a study of a specific reach within the DEC Project, the results must be analyzed relative to the different plans tested to provide the benefits of the various alternatives. Due to the size of the study channel and the need to present data over the entire study reach, the previously presented channel configuration maps did not provide a detailed picture of the results. To appreciate the magnitude of the bank recession and plan effectiveness, cross-sections were plotted for three study ranges (Ranges 19, 24, and 31). Those ranges were selected because Range 19 was approximately midway through the bend, Range 24 was near the end of the bendway, and Range 31 was the maximum point of bankline recession during the base tests. The cross-sections (looking downstream) from the right top bank (el 0 ft) to about the centerline of the channel are presented on Plate 11.

Results indicated that at Range 19 the top bank receded approximately 1.6 ft during the base test with little or no recession on Tests 1 through 3. At Range 24 results indicated top bank recession of approximately 1.6 ft during the base test and progressively less recession as the bendway protection structures were lengthened. That is, the LMK hard points (Test 3) had more erosion than Test 2 weirs, which had more erosion than Test 1 weirs. At Range 31 the maximum recession of 2.0 ft occurred during the base test with the continued trend of progressively less recession as the bendway protection structures were lengthened. The minimum recession with Plan 1 was about 0.8 ft; therefore, there was significant improvement in the scour reduction downstream of the bendway as a result of bendway weirs. It should be noted that Range 31 is located about 30 ft downstream of the most downstream weir; therefore, the effects of the weirs in redistributing the flow through and out of the bendway extended almost two channel widths (31.28 ft) downstream.
